Subject: Infrared Condition Analysis Report of Electrical Services at Your Church, 811 First Avenue West, Yourtown, Ontario, April 22, 2002

INFRARED CONDITION ANALYSIS REPORT

**YOUR CHURCH
811 FIRST AVENUE WEST**

Project No. IRES 7777 777

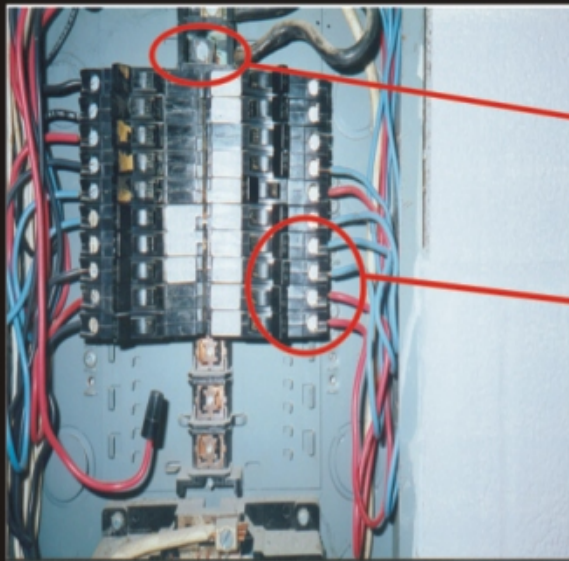
FAULTS #:
1 & 2

LOCATION OF FAULT: Church (Basement by Kitchen)

FEDERAL PACIFIC 70A (assumed) 120/208V
Distribution Panel

MAINTENANCE
PRIORITY: 2

1. Bottom Phase in feed to panel.

2. Circuit breakers 14 to 20 inclusive

Circuit 14: 12.5 A on 20A 1p breaker – **overloaded**

Circuit 16: 13.25 A on 20A 1p breaker – **overloaded**

Circuit 18: 12.5 A on 20A 1p breaker – **overloaded**

Circuit 20: 12.5 A on 20A 1p breaker – **overloaded**

COMMENT : Conventional Photograph

Circled areas are fault locations.

REMEDIAL ACTION: Repair cable at Fault 1. Investigate reasons for overload on breakers then redistribute loads at Fault 2. **Repair as soon as possible.**

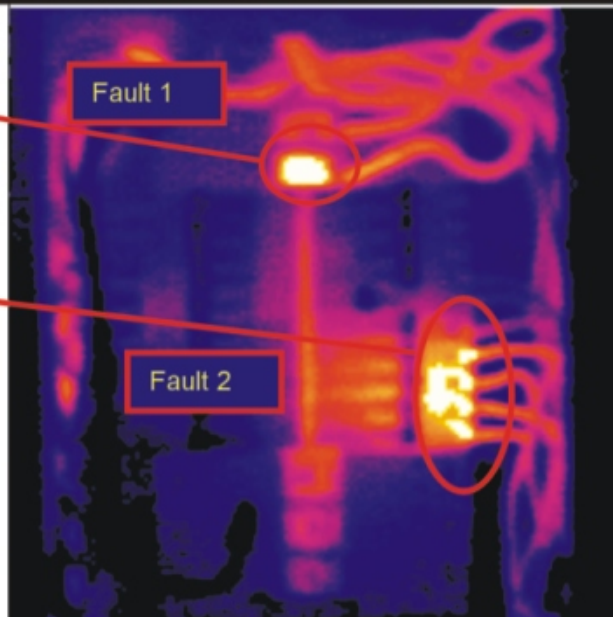
24.6 C

MEASURED (HOT SPOT)
40.7 C

16.1 C

COMMENT: Thermogram Image

Corresponds to conventional image at left.

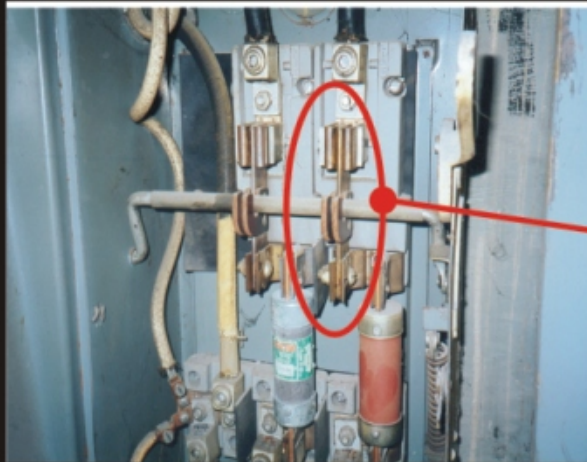
3

LOCATION OF FAULT: Church (Basement Electrical Room)

LANGLEY ELECTRIC 200A 125/250V

PRIORITY: 1

B Phase top in gear blades.

COMMENT : Conventional Photograph

Circled area is fault location.

REMEDIAL ACTION: Clean and tighten components. **Immediately.**

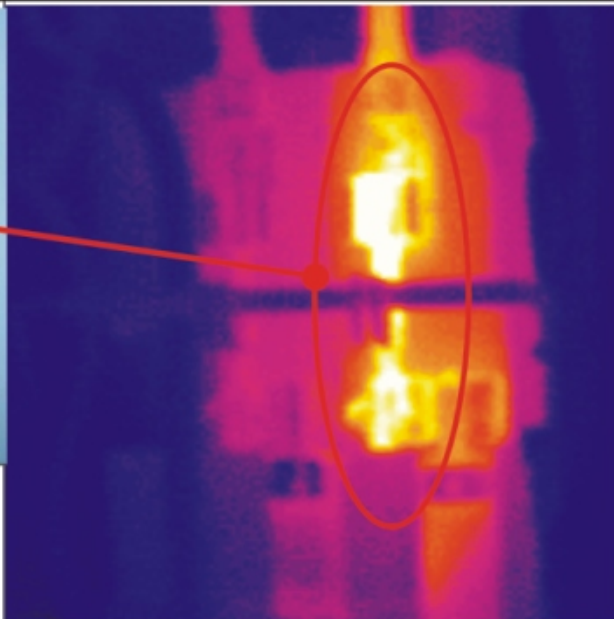
19.8 C

48 C

28.2 C

COMMENT: Thermogram Image

Corresponds to conventional image at left.

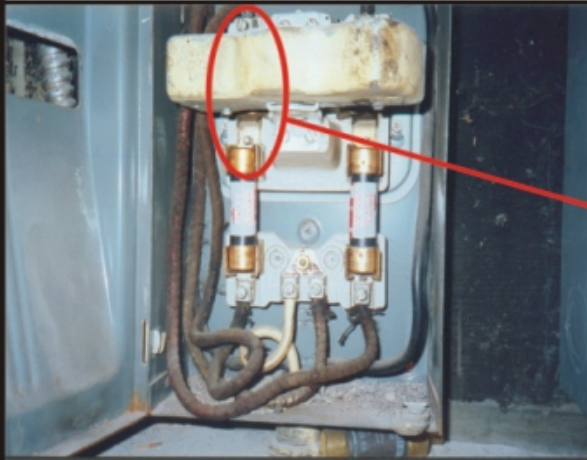
4

LOCATION OF FAULT: Church (Main Electrical Room Basement)
"KITCHEN FUSE BASEMENT"
No specifications or identification.

MAINTENANCE
PRIORITY: 2

Top of A Phase in gear and fuse clip.

COMMENT : Conventional Photograph

Circled area is fault location.

REMEDIAL ACTION: Clean and tighten. **As soon as possible.**

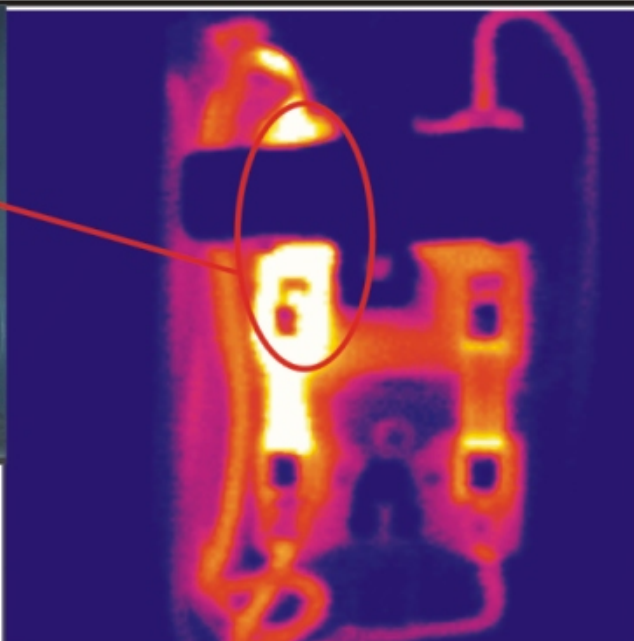
23.3 C

MEASURED (HOT SPOT)
35.7 C

12.4 C

COMMENT: Thermogram Image

Corresponds to conventional image at left.
