**Subject: Structural Condition Analysis Report of Parking Lot Light Standards at The Best Plaza,
1550-1556 Big Top Road, Mytown, Ontario, June 14, 2001**

STRUCTURAL CONDITION ANALYSIS REPORT
OF
PARKING LOT LIGHT STANDARDS
AT
THE BEST PLAZA
MYTOWN, ONTARIO
PREPARED FOR
TOPCORP MANAGEMENT SERVICES LIMITED

Project No. UST 8888-888

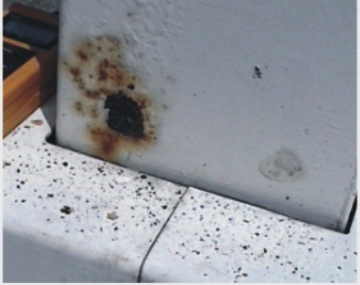
LIGHT POLE #	METAL TESTING RESULTS							
	THICKNESS (In.)				REMARKS			
	Min. Spec'd: .125/35' pole .149/40' pole							
	N	S	E	W	Condi tion	Prio rity	Comments	Sample Photographs
1 9"x9" Square tube tapered 40 ft., 2 head	.131 .126 .127 .131 .139	.203 .135 .138 .134 .178	.131 .131 .133 .134 .147	.138 .135 .133 .132 .140	Good	2	1. Surface corrosion S. side of pole base to half height of pole. Minor corrosion interior.

1.	STEEL POLE: GOOD POWCO: 9"X9" tube, tapered, 40 ft., painted white. Surface corrosion S. side of pole base to half height of pole. Minor corrosion interior. CONCRETE BASE: GOOD Unpainted	N/A	1. Remove surface corrosion, prime and repaint.		Yes	N/A	N/A

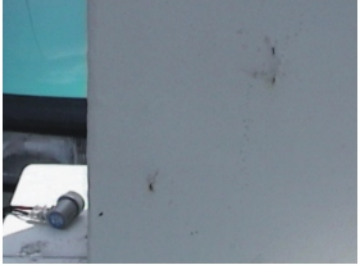
2 9"x9" Square tube tapered 40 ft., 2 head	.143 .134 .138 .129 .125	.144 .128 .125 .125 .135	.135 .138 .137 .135 .136	.130 .132 .133 .136 .144	Good	2	1. Minor surface corrosion S. side. No corrosion interior.

2.	STEEL POLE: GOOD POWCO: 9"X9" tube, tapered, 40 ft., painted white. Minor surface corrosion S. side. CONCRETE BASE: GOOD Unpainted	N/A	1. Remove surface corrosion, prime and repaint.	N/A	Yes	N/A	N/A

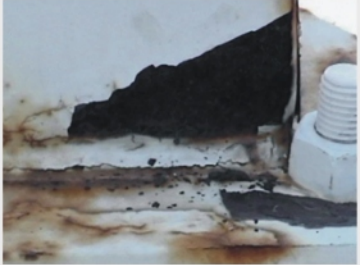
3 8"x8" Square tube tapered 40 ft., 2 head	.094 .073 .078 .100 .201	.120 .121 .105 .197 .197	.095 .210 .115 .118 .074	.071 .070 .074 .081 .081	Fair	1	1. Significant corrosion on S. side of pole.

3.	STEEL POLE: FAIR DYNAPOLE: 8" x8" square tube, tapered, 40ft, painted white. Significant corrosion on S. side of pole. CONCRETE BASE: GOOD Unpainted.	1. Remove surface corrosion and repaint.	N/A	N/A	Yes	N/A	N/A

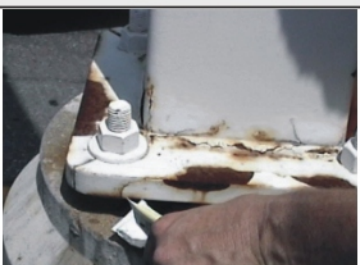
4 8"x8" Square tube tapered 40 ft., 2 head	.205 .121 .208 .210 .079	.077 .090 .081 .080 .080	.092 .070 .075 .094 .101	.117 .074 .205 .208 .259	Good	2	1. Minor surface corrosion W. side exterior at base. Minor corrosion interior

4.	STEEL POLE: FAIR DYNAPOLE: 8" x8" square tube, tapered, 40ft, painted white. Minor surface corrosion W. side exterior at base. Minor corrosion interior CONCRETE BASE: GOOD Unpainted.	N/A	1. Remove surface corrosion, prime and repaint.	N/A	Yes	N/A	N/A

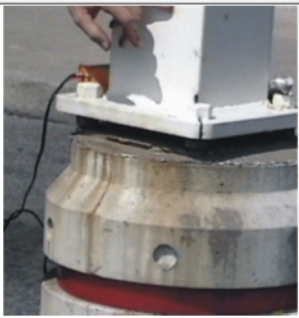
9"x9"	.219	.200	.217	.223				
Square	.203	.205	.207	.203				
tapered	.200	.205	.203	.200				
2 head	.203	.207	.202	.201				
8	.229	.211	.211	.216	Good	2	1. Minor surface corrosion at base of pole and S. surface. 2. Minor surface corrosion S. side of pole. 3. Minimal interior corrosion. 4. No bolt covers.
